SITE VISIT REPORT FEMA-4233-DR-TX

WORKORDER # 4493

APPLICANT: San Augustine, City of

Facility: Park St Culvert

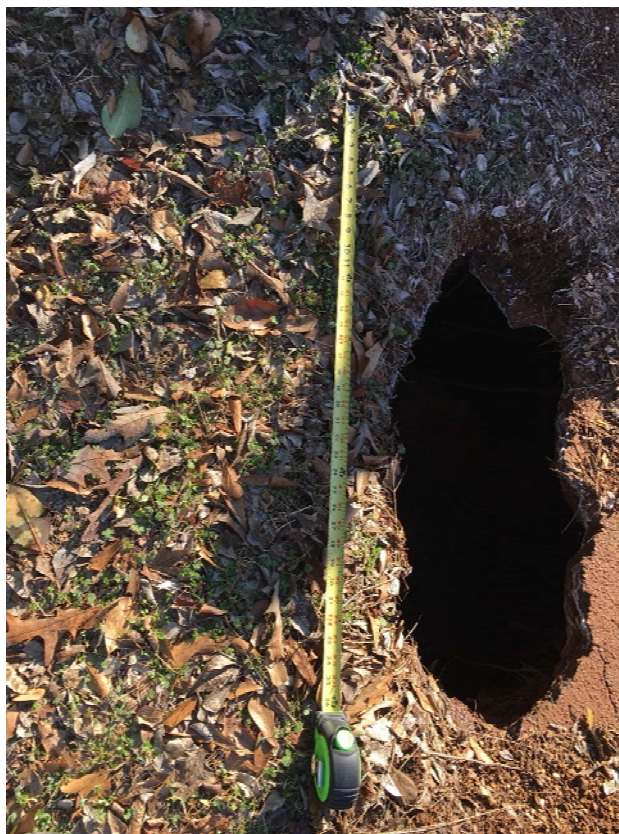
The Park Street runs beside the tow park. The damage is a sink hole caused by water undermining the road at a drainage culvert. The hole is approx. 15" x 36". The culvert itself was found to be dry. There was no water. The culvert is a combined CMP and RCP that is 30" dia and 24' long. At the time of the inspection it was unknown whether there was damage done to the culvert. The applicant is unsure at this time how they intend to repair the site. It is expected that they will contract the work out.

Photo 1: Park St. Sink hole created during the storm.

Suggested mitigation for this site is to install a headwall for the culvert on the north side of Park St.

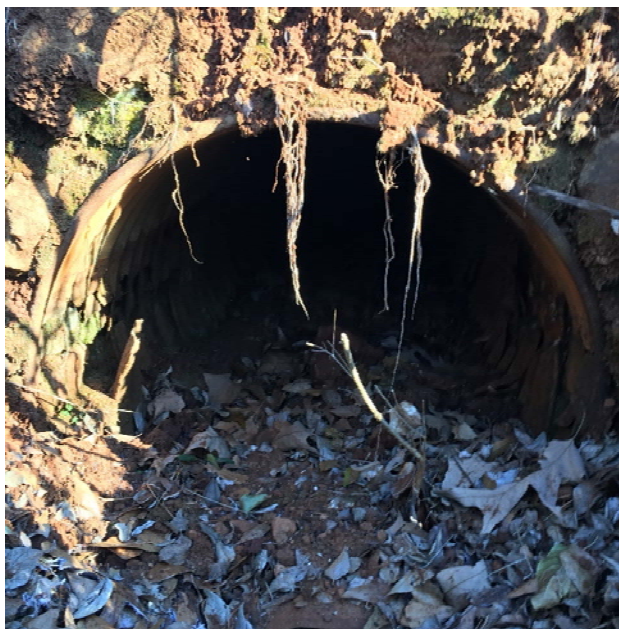
Photo 2: South end of Park St. culvert. Culvert is dry.

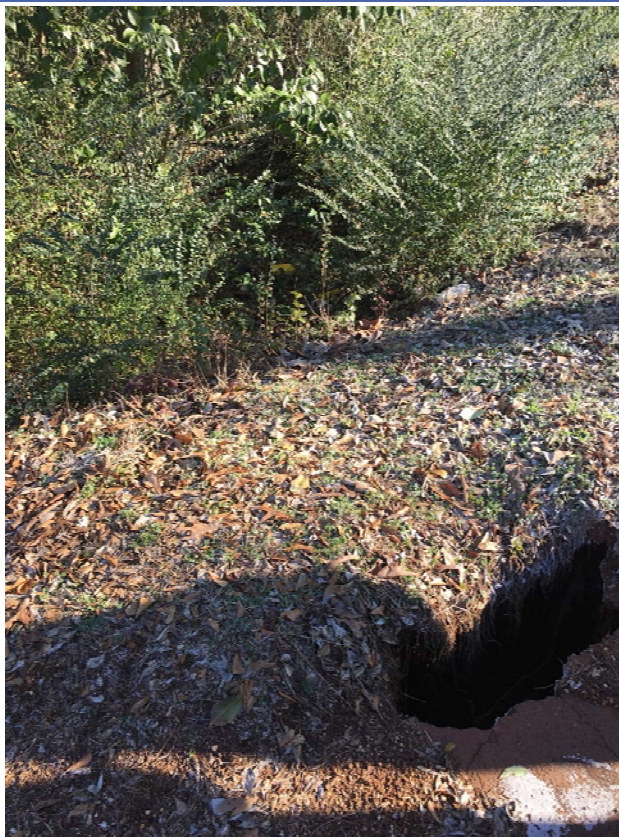
Photo: 3 North side of Park St. showing the culvert.

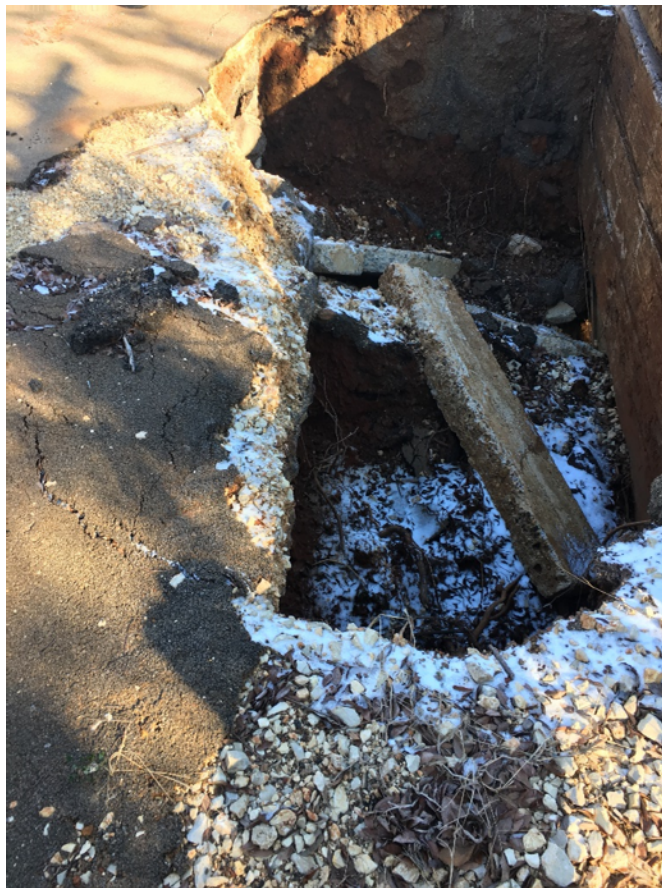
Goldenway culvert/bridge is located on the outskirts of the City of San Augustine in a residential area. The structure consists of a central 48" dia. x 28' long CMP that has been crushed. This pipe has an overflow pipe on either side of the main pipe, that are 30" dia x 28' long. The CMP plugged and the water overtopped the road causing erosion on both sides of the structure. The Goldenway is currently closed to traffic. The damage is such that the applicant does not feel that what is remaining of the bridge/culvert is repairable and that a new facility needs to be constructed. There is also concern that the culverts were insufficient in size and need to be upsized.

Photo 7: Goldenway Bridge /Culvert showing the degree of erosion that occurred during the storm event.

Suggested mitigation for this site is to replace the existing structure of culverts and fill with a full span bridge. Should this mitigation be implemented, co-ordination with the USACE Fort Worth District is imperative

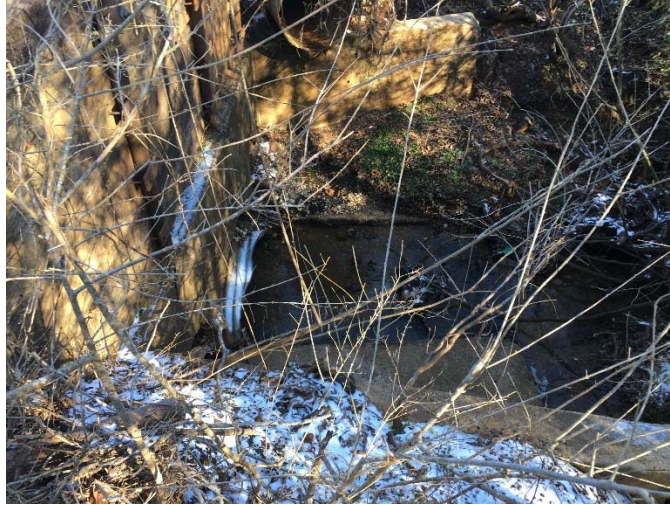
Photo 8: Upstream (east) side of road structure. Showing 48" dia CMP pipe.

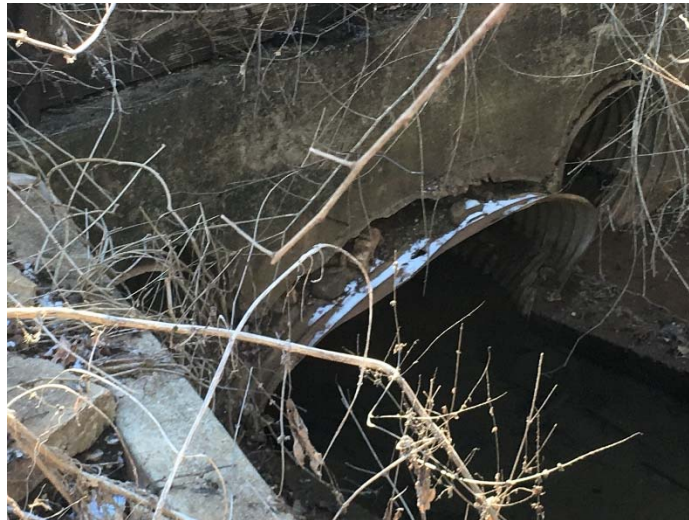
Photo 9: Downstream (west) side of the drainage structure showing main pipe and the overflow pipe

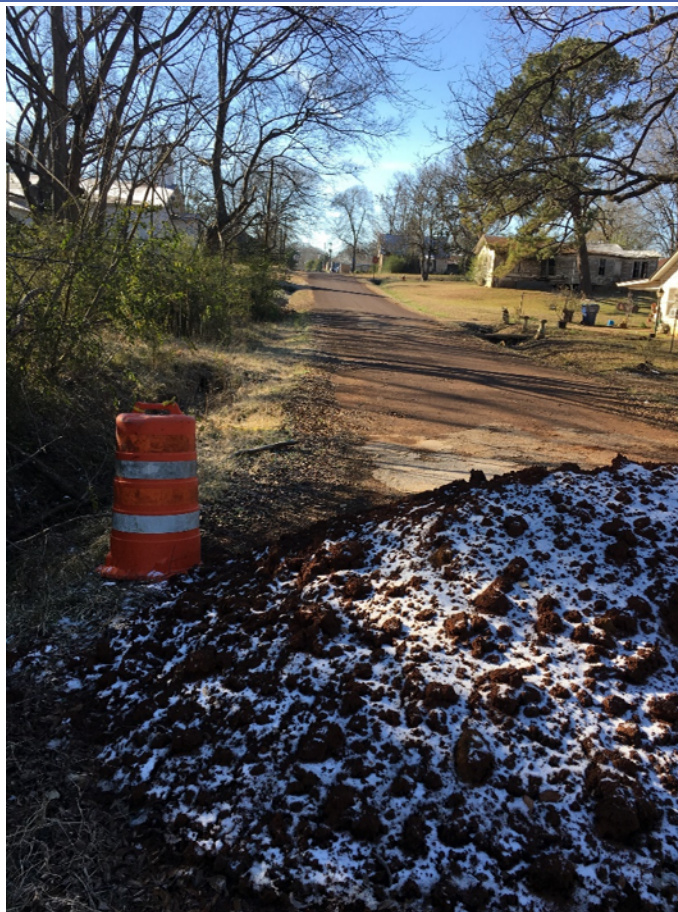
Photo 10: Goldenway looking south. The dirt was placed on the roadway by the city to stop traffic from crossing the bridge/culvert

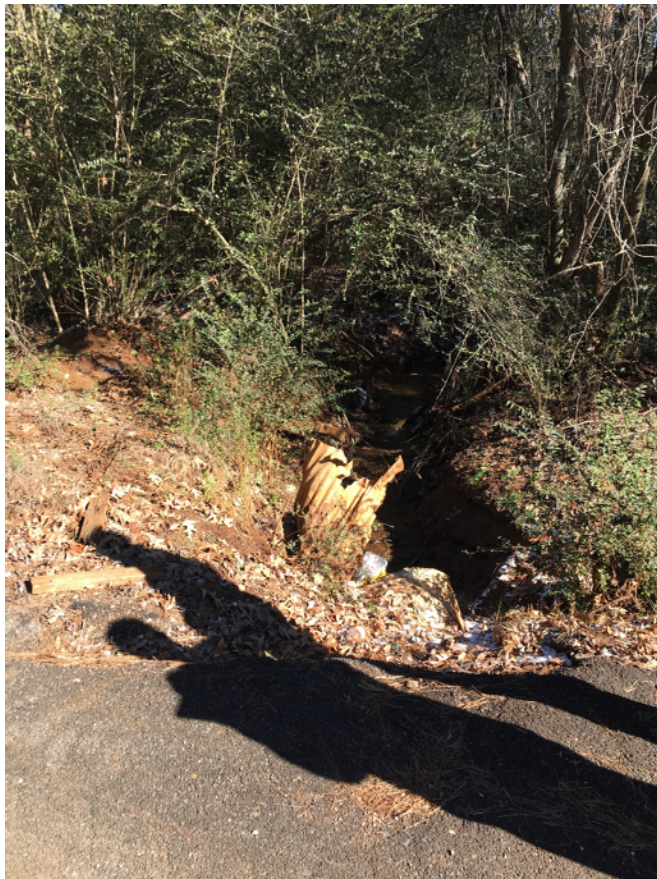
Bierhalter St is located in wooded area north of the residential areas of the city of San Augustine. Most of the damage is washed out road surface. There is a damaged culvert, 30" dia x 22' long. There is damage to the north end of the culvert. The south end of the culvert has a monolithic concrete headwall and wing walls cast around it. The applicant is reluctant to replace the culvert because of this headwall.

Photo 11: Damaged Culvert on the north side of Bierhalter Rd.

Construction of a headwall on the north side of the road has been proposed as hazard mitigation for this site. Should this mitigation be implemented, co-ordination with the USACE Fort Worth District is suggested.

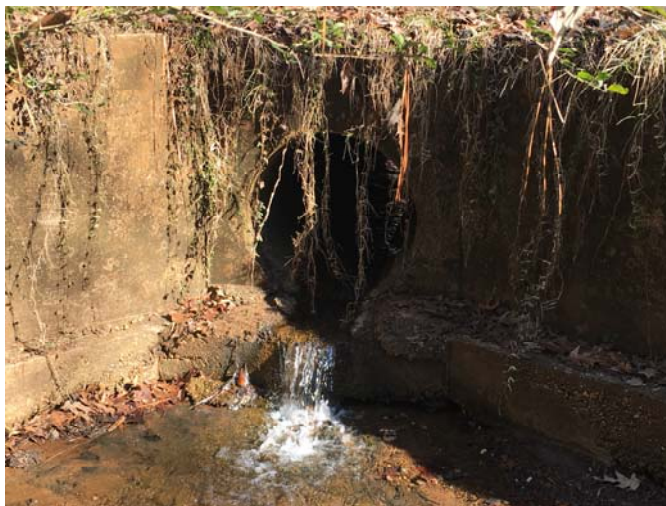
Photo 12 : Outlet of culvert, showing headwall encasing the culvert

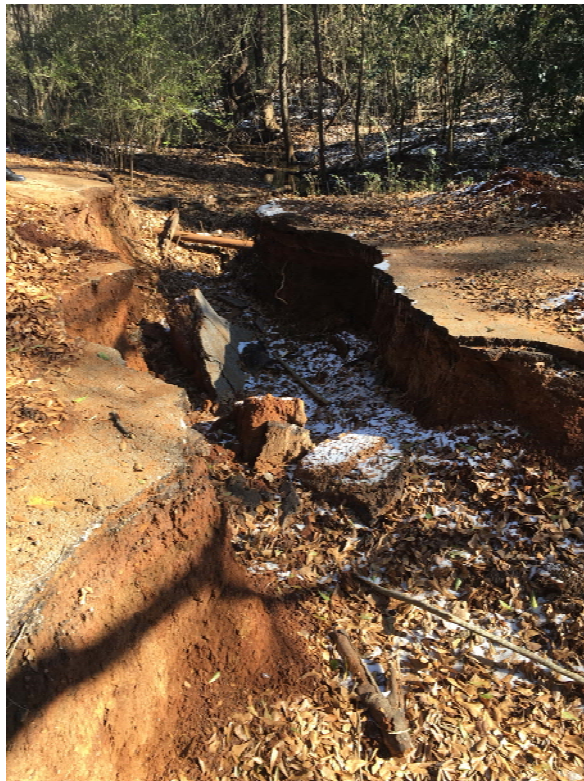
The culvert at this location was completely destroyed and the road is closed to traffic. The culvert was a 42" dia. 24' long concrete pipe. The hole that was cut by the water is 8' wide by 24' long to a depth of approx. 4'.

There are several utility lines that have been exposed as a result of the washout including water and gas lines.

Photo 16: Washout on Milan St. facing west

Construction of a headwall on both ends of the culvert has been proposed as hazard mitigation for this site. Should this mitigation be implemented, co-ordination with the USACE Fort Worth District is suggested.

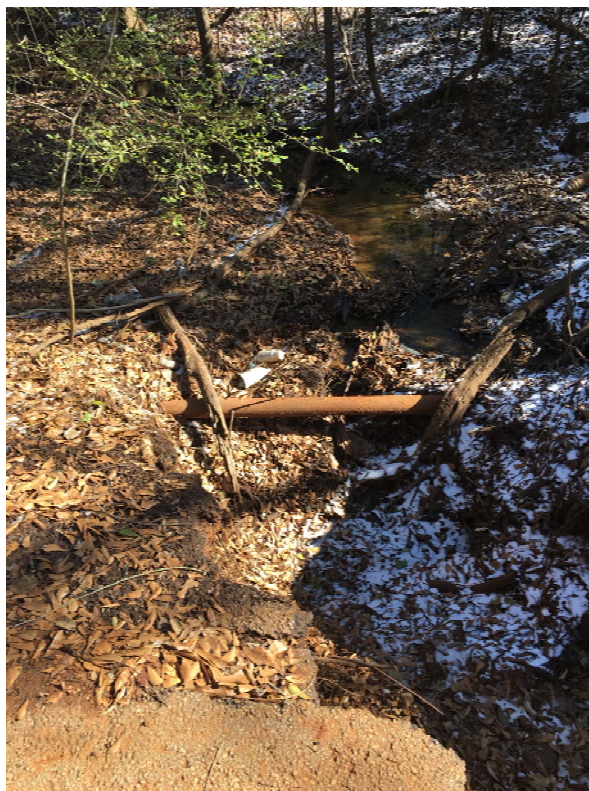
Photo 17: Damage site looking south downstream.
